| <b>TITLE:</b><br>Factory Tie-ins for Lighting/Mirrors/Back-up System | | |
| <b>COMMENTS</b><br>JOB # CI250 | | <b>REV</b><br>0 |
| <b>SIZE</b><br>B | E250-01-00 | |

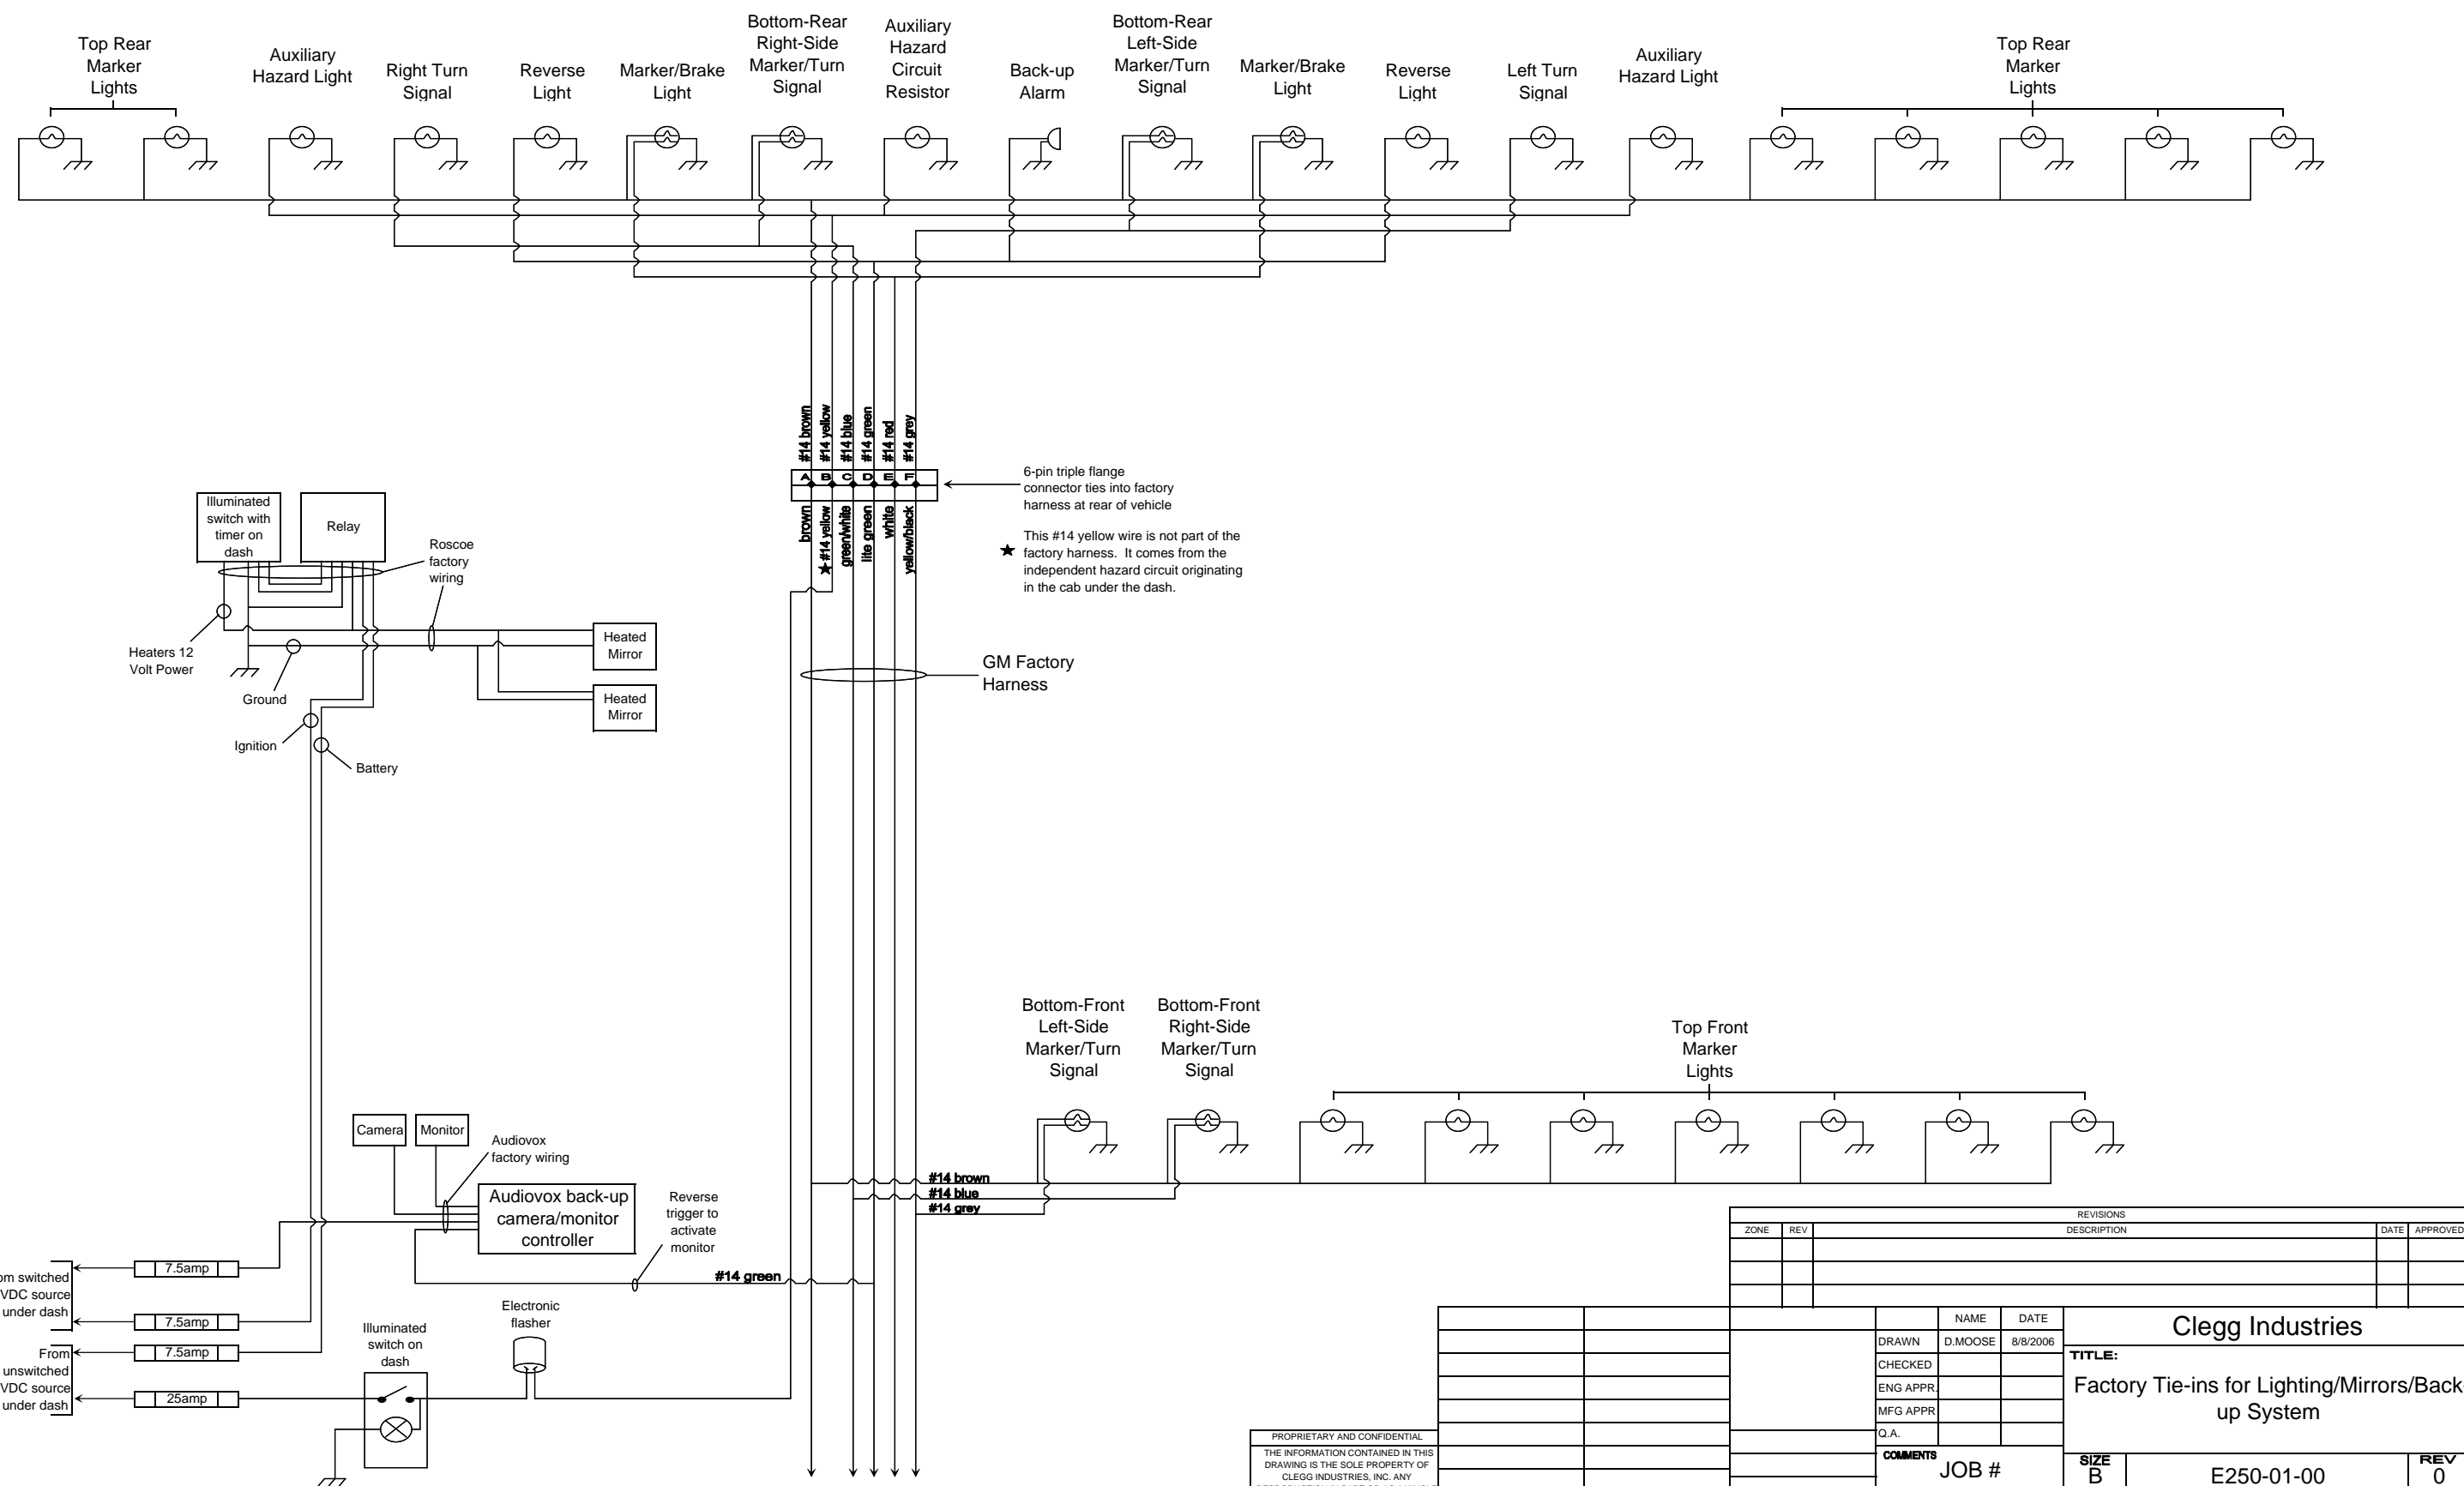
6-pin triple flange connector ties into factory harness at rear of vehicle

★ This #14 yellow wire is not part of the factory harness. It comes from the independent hazard circuit originating in the cab under the dash.

GM Factory Harness
